## **SECOND NOTICE OF VIOLATION, CONSTRUCTION STORM WATER GENERAL PERMIT NO. CAS000002, DEL RAPINI CONSTRUCTION INC, WDID NO. 5S03C337319, AMADOR COUNTY**

# Storm Water Construction General Permit Inspection Report

WDID # 5S03C337319

Pine Grove Bluffs

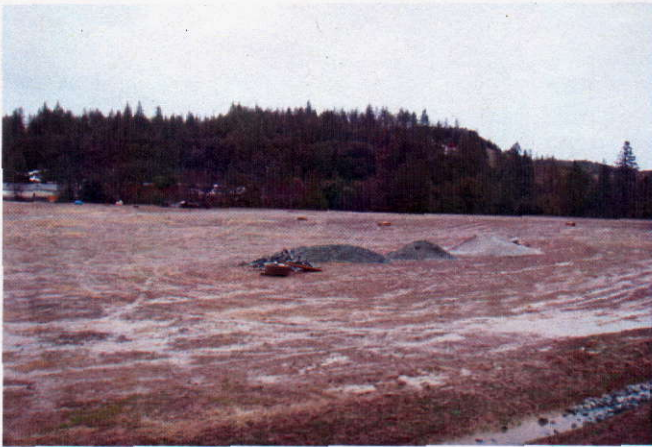
**Figure 1:** Overview of site, showing inadequate storm water BMPs. Storm water sheet flows to conveyance channels like that shown in Figure 2.

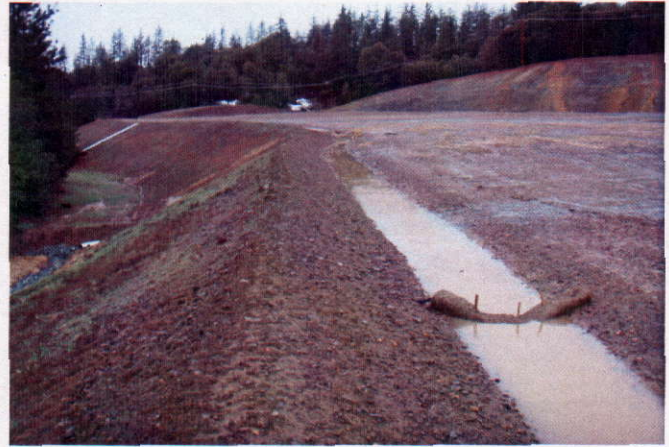
**Figure 2:** One of the channels directing storm water to a culvert that discharges under Highway 88, directly into Jackson Creek.

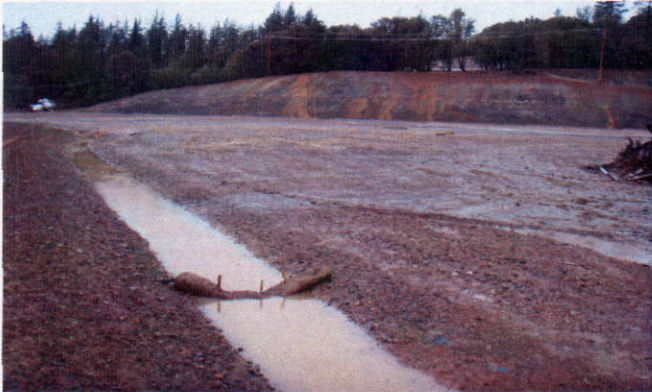
**Figure 3:** Another view of a portion of the project. Note the lack of BMPs.

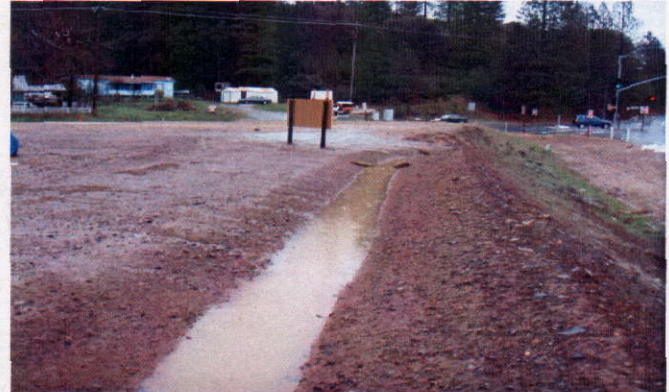
**Figure 4:** Another portion of the project.

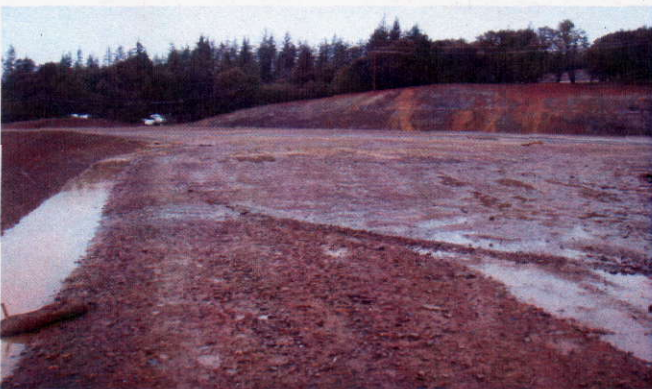
**Figure 5:** Another view of the graded area.

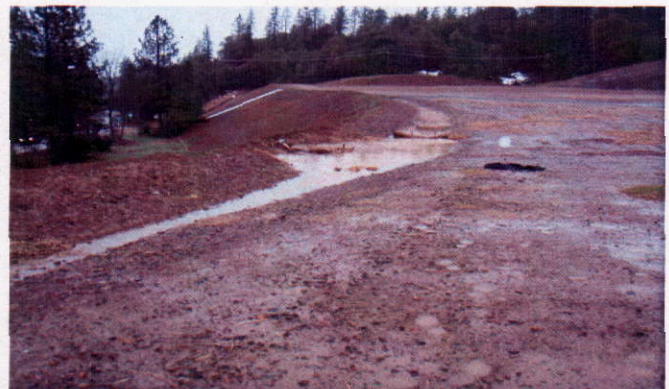
**Figure 6:** Turbid storm water discharging into the culvert.

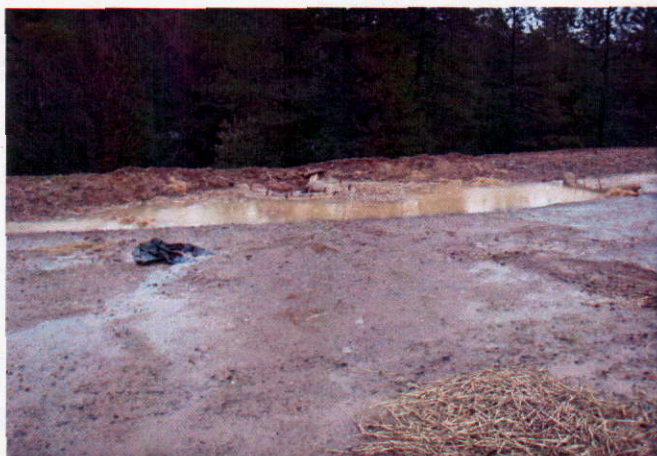
**Figure 7:** Turbid storm water sheet flowing to a culvert which conveys storm water down slope.

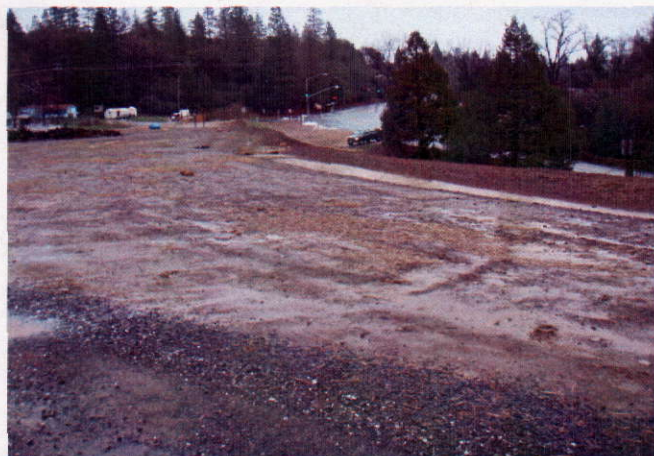
**Figure 8:** Another portion of the project without effective storm water management BMPs.

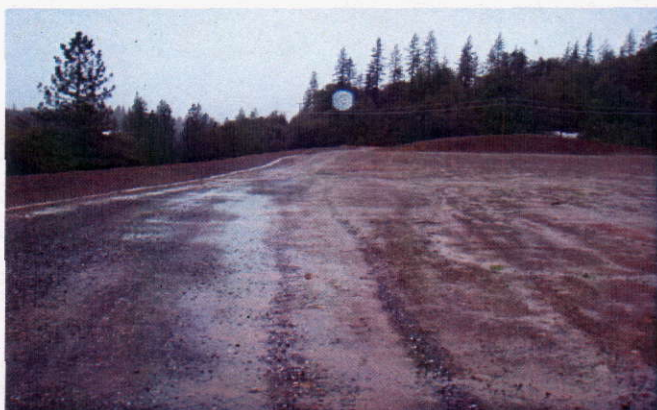
**Figure 9:** Another view of a portion of the flat pad without effective BMPs.

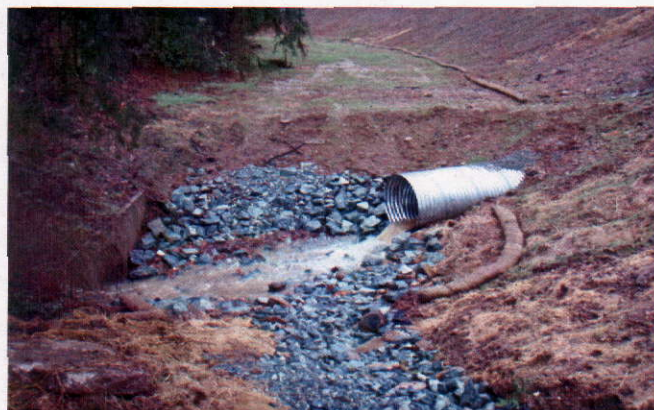
**Figure 10:** Turbid discharge from the project flowing from the eastern culvert.

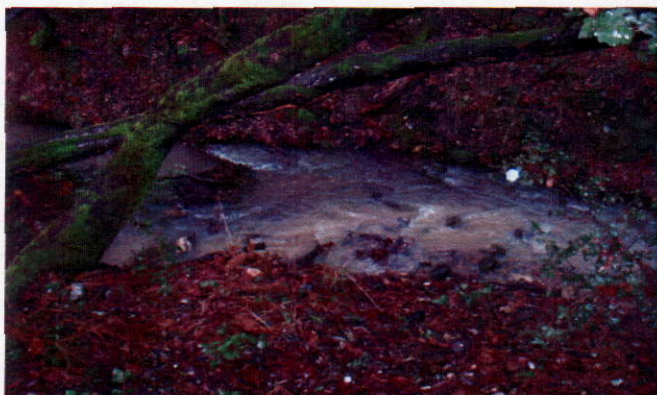
The discharge of sediment-laden water from your site is a violation of Discharge Prohibition A.3 of the General Permit, which states, "*Storm water discharges shall not cause or threaten to cause pollution, contamination, or nuisance.*" Sediment-laden storm water discharges from your construction site threatened to cause a condition of pollution and/or nuisance in Jackson Creek; therefore, you are in violation of Prohibition A. 3 (see photographs 11, 17, 18).

**Figure 11:** Turbid discharge from the eastern culvert mixing with clear flow in Jackson Creek.

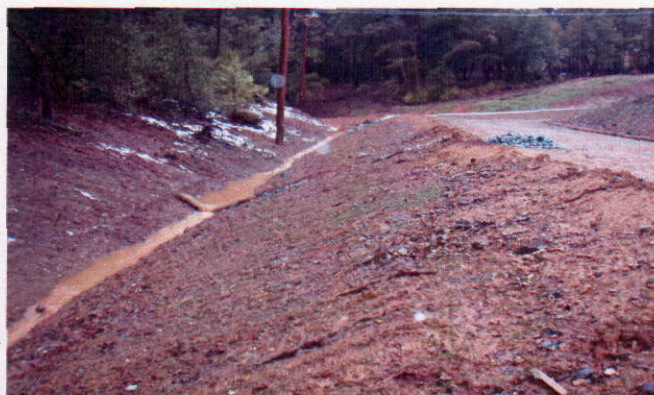
**Figure 12:** Partially stabilized slope on the western side of the project.

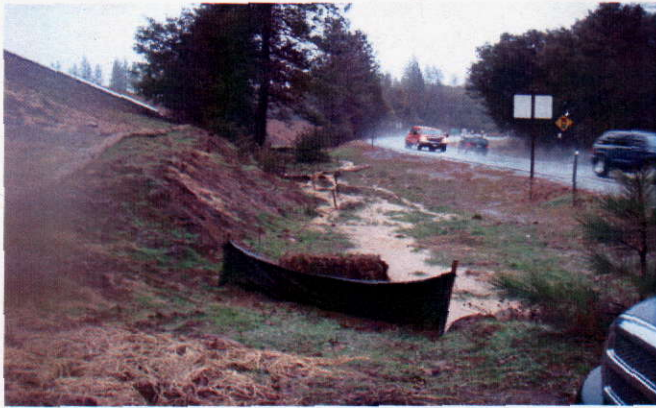
**Figure 13:** Discharge from the site flowing along the Highway 88 right of way.

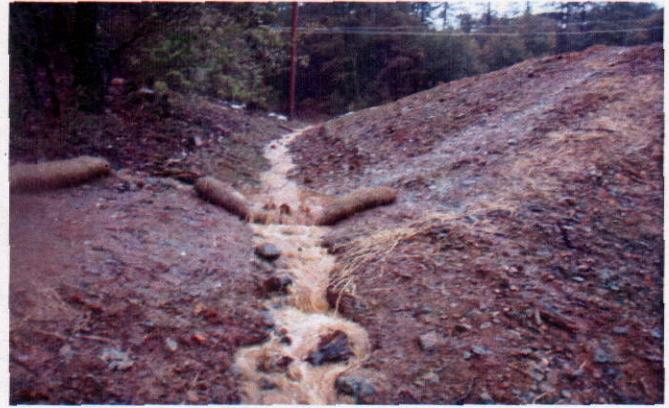
**Figure 14:** Discharge from the site cutting into the bank on the western side of the project.

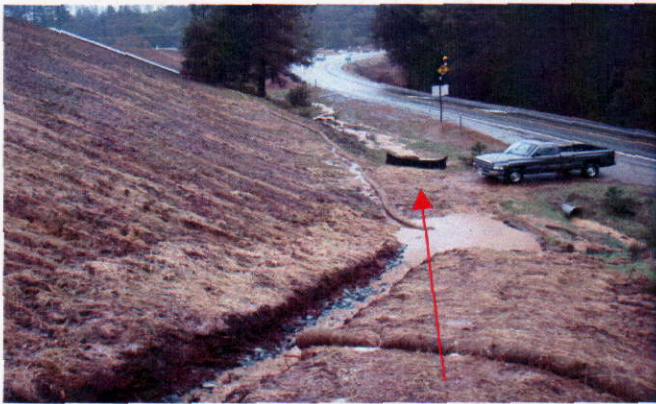
**Figure 15:** Turbid storm water from the project flowing down to the discharge location.

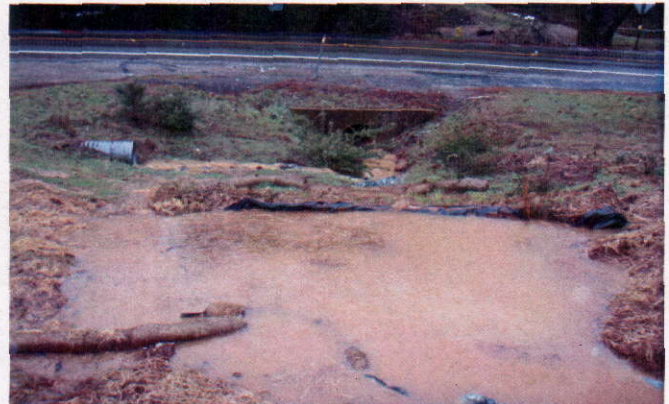
**Figure 16:** Very turbid storm water from the site discharging into the western culvert.

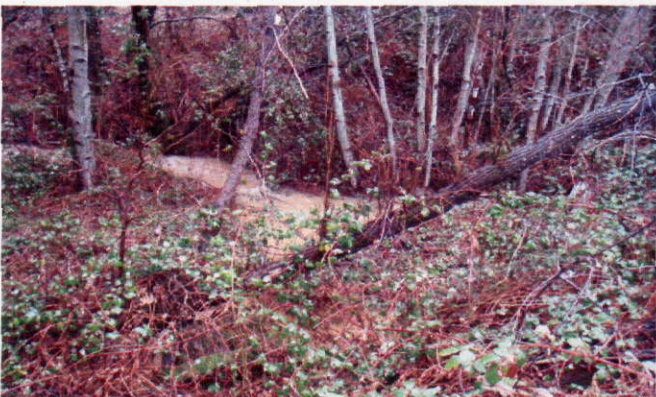
**Figure 17:** Storm water from the western culvert mixing in Jackson Creek. The water in Jackson Creek was already turbid from the upstream discharge from the eastern culvert of the project shown in Figure 10

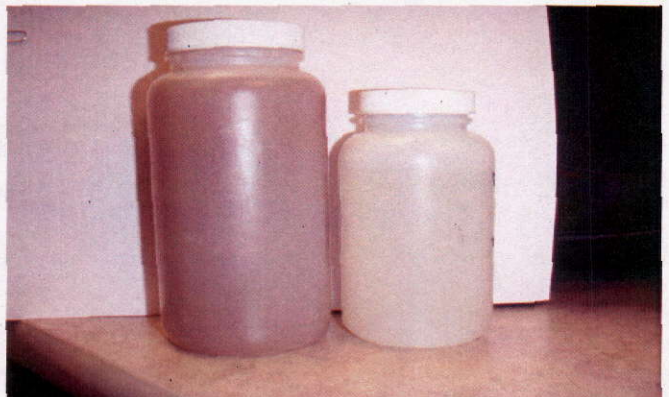
Staff took field measurements of turbidity in Jackson Creek at two locations, upstream of discharges from your site and at the location of the downstream discharge from your site. The upstream turbidity was measured to be 30 NTUs, and turbidity at the western discharge location was measured to be 979 NTUs.

During the site inspection staff observed significant storm water management problems on the construction site. These problems included the general lack of an effective combination of sediment and erosion control BMPs in many areas of the project, poorly protected drain inlets and turbid storm water discharge from the construction site at two locations (see inspection photographs). Similar problems were observed during the last inspection on 1/24/09. The inspection was conducted during a significant rain event. The discharge at from the western culvert was sampled and discharge upstream of the eastern culvert was sampled for a baseline reading in the creek. The samples were then field tested using a Hach 2100P turbidimeter and the upstream reading in Jackson Creek was 30 NTUs and the western discharge location was 979 NTUs (see photograph # 18).

**Figure 18:** Bottles with water samples taken from Jackson Creek. The larger one was taken at the western culvert with a turbidity of over 900 NTUs. The smaller one was taken upstream of site, with a turbidity of 30 NTUs.
